MOTORCYCLE SERVICE NEWS

267

YAMAHA INTERNATIONAL CORPORATION
MONTEBELLO, CALIFORNIA

XS1(B) IGNITION TIMING CHANGE

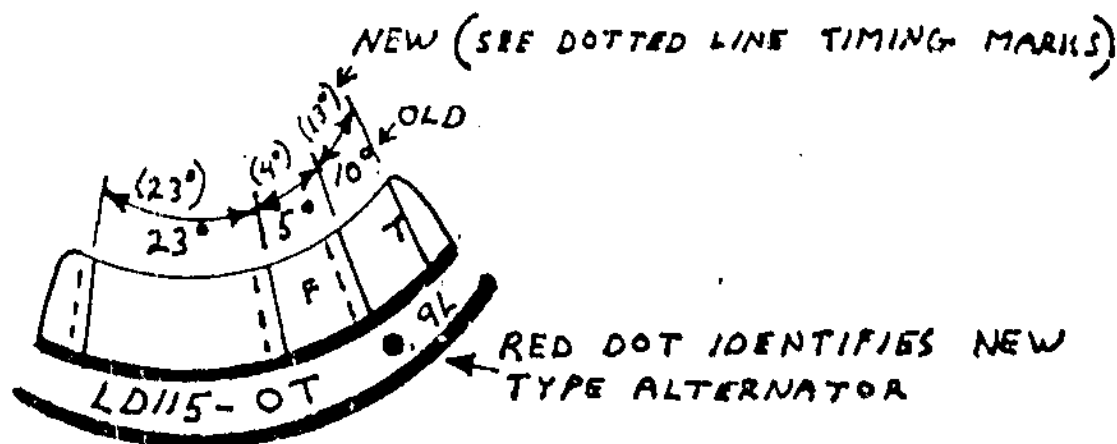
This change in timing marks was included on machines from engine number 11764. The alternator with modified marks can be identified by a red dot on the stator, located in line with the first "retard" timing mark.

To achieve identical timing with old alternator equipped XS1's, set timing at the second timing mark (15° BTDC). This will automatically make full advance timing to occur at 40° BTDC. Double check with timing light.
