# ADDITIONAL PRE-DELIVERY SERVICE INSTRUCTIONS

All XS650F  
All XS650SF  
All XS650-2F

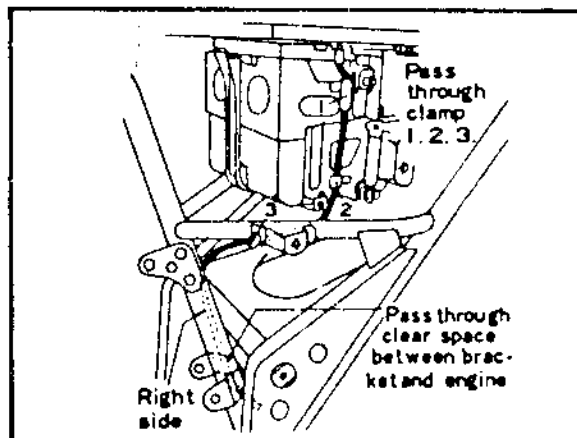
1. The routing diagram under the seat and in the assembly manual is correct but does not show the lower portion of the vent tube.
