XS1100H/LH/SH

DRIVE AXLE BEARING COLLAR

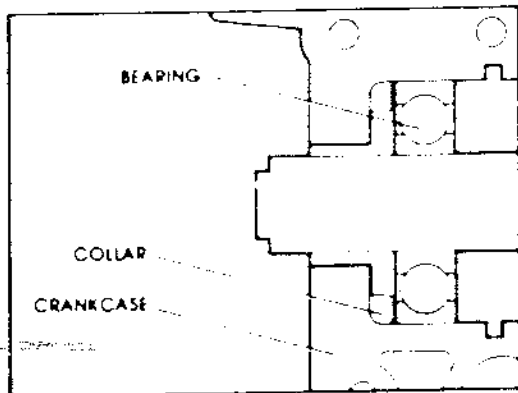
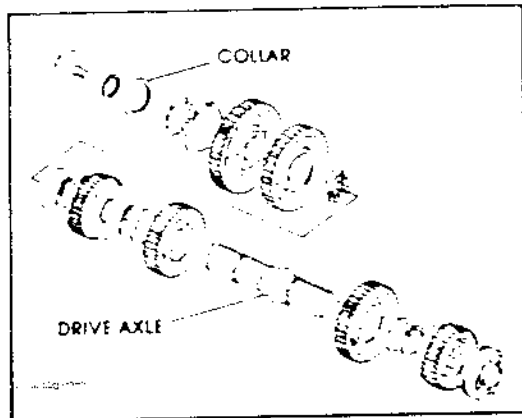
A new-style bearing supports the right-hand side of the transmission drive axle on the affected models. This new-style bearing is a single-row ball bearing rather than a double-row bearing as used in previous XS11s. Since the new-style bearing is 3mm narrower than the bearing previously used, a collar has been installed between the bearing and the crankcase to maintain the proper clearances in the transmission. This collar is directional; it must be installed with the beveled edge toward the crankcase and away from the bearing.

If the collar is positioned improperly during assembly, the crankcase will be damaged when the drive axle bearing is installed. Be sure the bearing collar is installed correctly before pressing the drive-axle bearing into the crankcase.
